**Examination of Spray-Applied Oxsilan 9810/2 Steel
Pretreatment on a Mine Resistant Ambush Protected
(MRAP) Vehicle**

ARL-TN-578

October 2013

Jack Kelley and Tom Braswell
Weapons and Materials Research Directorate, ARL

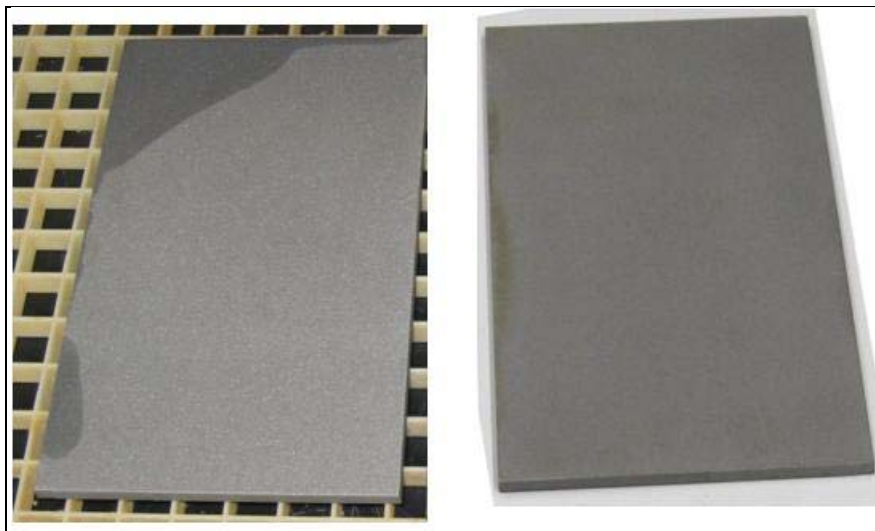
Following the ANAD demonstration, HHA test panels were treated using the same batch of the Oxsilan 9810/2 used on the Strykers during the ANAD demonstration. These test panels were treated with the remaining Oxsilan 9810/2 in order to conduct additional accelerated corrosion tests and humidity testing. Below in figure 3 are pictures of a sample treated with the ANAD batch of Oxsilan 9810/2. Once again, no discoloration was observed on the panels.

Figure 3. A panel treated with the same batch of Oxsilan 9810/2 from the ANAD demonstration of Stryker (left), shown during drying (right), fully dried 24 h.

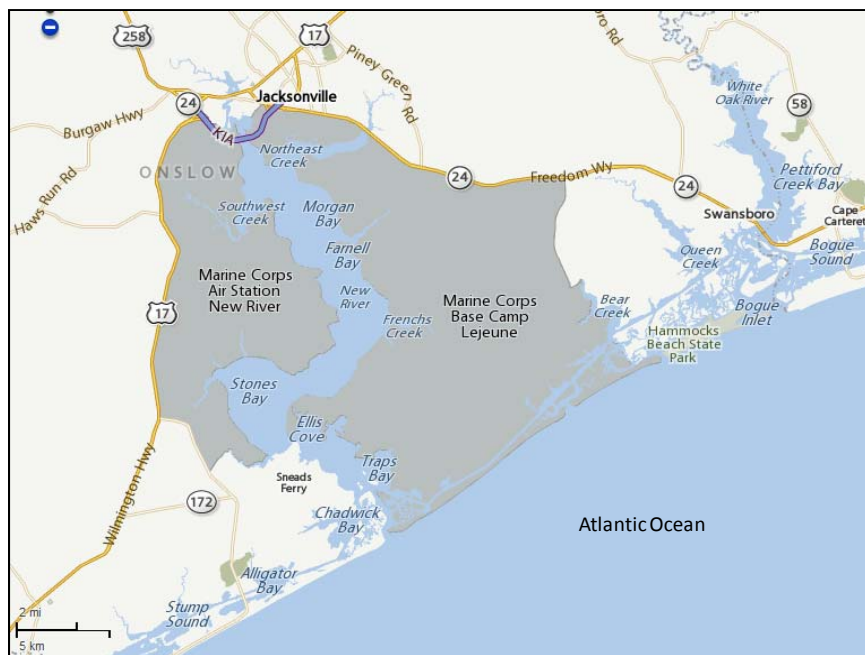
The results of the ARL HHA test panel experiments indicate that the unusual MRAP result was caused by multiple factors. The brownish-red color of the MRAP was most likely the product of both surface contamination, and insufficient flow and rinsing of the Oxsilan 9810/2. The surface may have been first contaminated by the blast media, which may have contained soluble salts, and/or by the bare freshly blasted steel being exposed to the uncontrolled environment near the Atlantic Ocean at Camp Lejeune, NC (figure 10) for 72 h. Ionogenic contamination from abrasives is transferred uniformly onto steel surfaces. This can turn the steel surface a homogeneous light-gray-to-black color, depending on the concentration (11). The trucks were light-gray with no noticeable corrosion before treatment. But once the pretreatment was applied (using insufficient flow rate in this case), the reaction produced a corrosion-like color on the vehicle. Laboratory tests also indicate that it is possible for optimum flow of the Oxsilan 9810/2 to perhaps compensate for the contamination by essentially washing away the contaminants quickly enough to allow the Oxsilan 9810/2 organo-silane polymers to react with the cleaned metal, leaving a clean-gray finish behind. In addition to the panel testing, evidence of the advantage of the greater flow rate can be seen in the MRAP picture in figure 11. The light-gray streaks occurred at locations where there was a higher flow rate of Oxsilan 9810/2 (i.e., continuously running down the side).

Figure 10. Marine Corps Base, Camp Lejeune, NC. Site of demonstration is within close proximity to the Atlantic Ocean (12).
